DELAWARE RIVER BASING TRIBUTARY TO HAYNES CREEK BURLINGTON COUNTY NEW JERSEY

TIMBER LAKE DAM
NJ 00416

PHASE 1 INSPECTION REPORT C NATIONAL DAM SAFETY PROGRAM

May, 1979

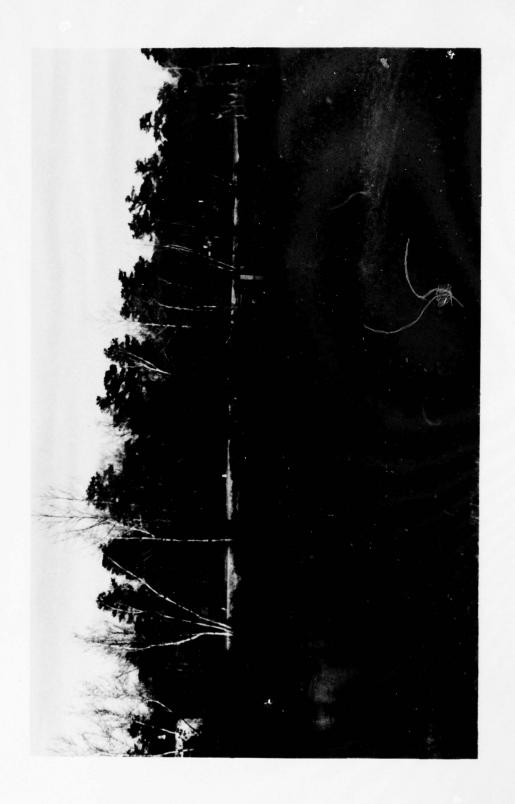
OVERVIEW - TIMBER LAKE DAM

Based on visual inspection, past operational performance and Phase I engineering analyses, Timber Lake Dam is assessed as being in fair overall condition.

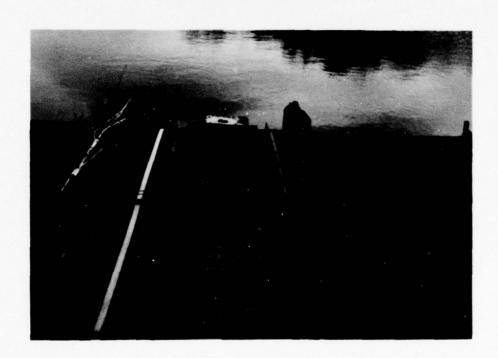
PHOTO 2

The steel grate and walkway covering the spillway is structurally unsound and hazardous and should be replaced very soon.

inspection. Water was flowing over the concrete weir section of the spillway and, therefore, the condition of much of the structure was not clearly observed. The steel grate platform and walkway covering the spillway was found to be structurally unsound and consequently dangerous.

STEEL PLATFORM OVER SPILLWAY. STOPLOGS AT END OF SPILLWAY.

- 4. A detailed design for regrading the upstream and downstream embankment slopes should be prepared by a qualified professional engineer and the embankment should be regraded accordingly.
- The steel grate and walkway covering the spillway should be replaced very soon.

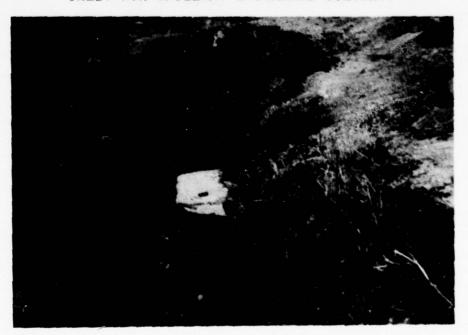
РНОТО 4

The spillway discharge culvert could be observed only at its inlet and outlet, and is almost completely submerged by tailwater at its outlet. The small portion of the culvert that could be observed indicated that the concrete is in satisfactory condition. There is no headwall at the outlet.

TAILWATER AT TOP OF SPILLWAY DISCHARGE CULVERT OUTLET.
